ENVIRONMENTAL ASPECTS OF TRANSFORMATION IN LANDSCAPE SURROUNDING PLZEŇ ON THE EXAMPLE OF LUČNÍ POTOK - BROOK CATCHMENT AREA

Abstract: The paper deals with environmental impacts of the landscape transformation, especially hydric part of landscape. Changes are demonstrated on the example of Luční potok - brook catchment area. We discuss impacts of motorway construction, changes of airport area function and revitalisation of water reservoir.

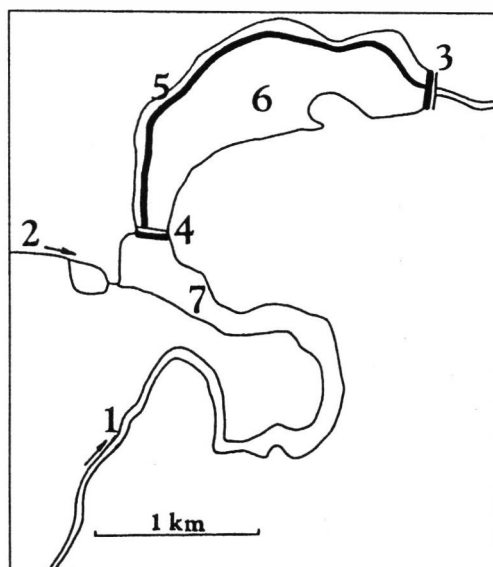
Fig. 2 The revitalizing project of the water reservoir České údolí
 1 - the Radbuza river, 2 - the Luční potok - brook, 3 - main dam,
 4 - interior dam project, 5 - interior channel project, 6 - recreation
 part of reservoir, 7 - inflow part of reservoir

3. Luční potok - brook flows into the Radbuza river on the periphery of Plzeň in the point, where was finished the water reservoir České údolí in 1973. This reservoir was intended for the daily recreation for Pilseners. However, this reservoir does not serve for recreation because water quality does not agree with hygienic requirements (intensive vegetation turbidity produced by planktic algae and cyanophyte, pH 10 - 11). The cause is in bad technical parameters of reservoir and supplied nutrients from the catchment area. Supply of phosphorus is approximately 9 g.m⁻² reservoir in the dry year and 50 g.m⁻² reservoir in the aqueous year. The revitalising project considers reduction in nutrients' flow, rehabilitation of bottom sediments and above all change in reservoir's order. The water reservoir will be divided by gate dam to the inflow part and the part designed for recreation. The part for recreation will be lateral reservoir with area 0, 8 km². Passing water will go through the artificial channel in the left of reservoir straight to the main dam.

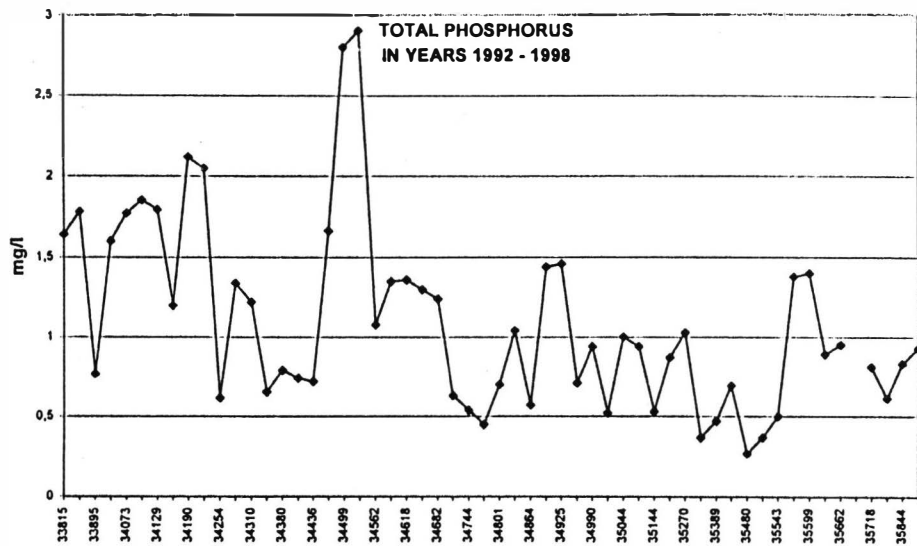
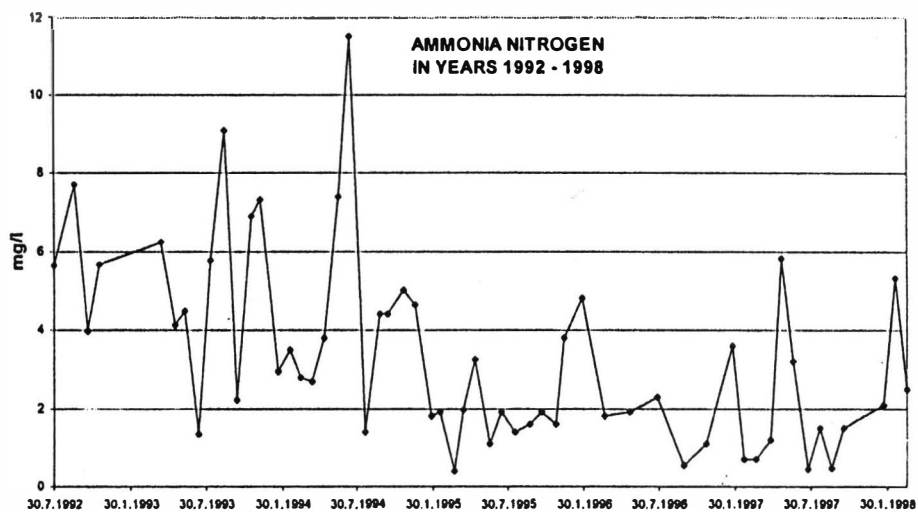
Fig. 3, 4 The Luční potok - brook water quality. Phosphorus and nitrogen - mildly positive trend in development ? (Státní meliorační správa)

The content of organic matters is increasing mildly, self - purification is intensive. Water areas and wetlands in the catchment area have a positive impact. Presence of phosphorus and nitrogen is increasing with mildly positive development tendency. Incidence of iron and manganese is very high. We suppose the impact of industrial outfall damp Sulkov and former mining activity.
